**Flood Control Project Maintenance
Levee Inspections****LMA District Cover Sheet****Spring 2012 Levee Inspection Results****Reclamation District No. 0817 Carlin**

Levee Inspection Report By Mile - Spring 2012

Reclamation District No. 0817 Carlin

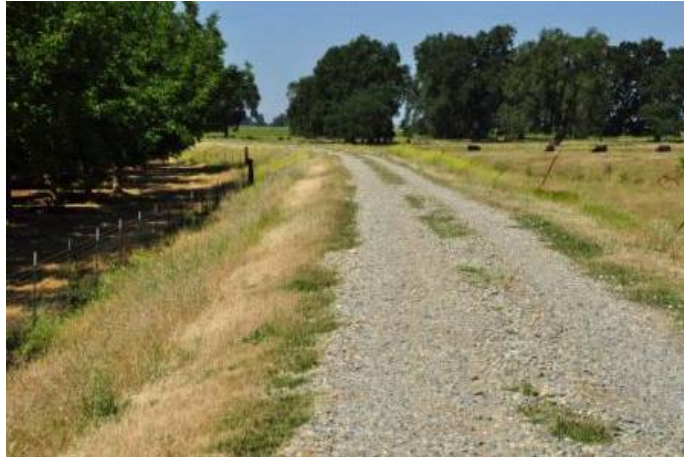
Levee Mile Report Line	4
Start Levee Mile	0.00
End Levee Mile	0.00
Location	Land Side
Category	Earthen Levee
Item	Vegetation
RD 817 Unit 1 - Vegetation	
rburnett_s_20120531_380.JPG

Waterway						Bank	Unit Miles	Inspection Start/End	Inspector	
Unit No. 01 South Dry Creek						Left	3.82	05/30/2012 05/30/2012	Rick Burnett	
LMR No.	Levee Mile		Category	Item	Location *	Rating + Ma	Action/Comment	GPS Latitude/Longitude		Issue No.
	Start	End						Start	End	Photo
1			Earthen Levee	Emergency Supplies & Equipment	LS	A	Inspector Comments: RD 817 & RD 2103 have a combined cache of flood fight material.	°	°	1
								°	°	
DWR ID: DWR_RD0817_01_s_2012_1										
2			Earthen Levee	Flood Preparedness & Training	LS	M		°	°	2
								°	°	
DWR ID: DWR_RD0817_01_s_2012_2										
3			Earthen Levee	Operations & Maintenance Manuals	LS	A		°	°	4
								°	°	
DWR ID: DWR_RD0817_01_s_2012_4										
4	0.00	0.00	Earthen Levee	Vegetation	LS	A	V1 : Control annual grass and weeds on the levee slopes and easements.	°	°	3
								°	°	Y
DWR ID: DWR_RD0817_01_s_2012_3

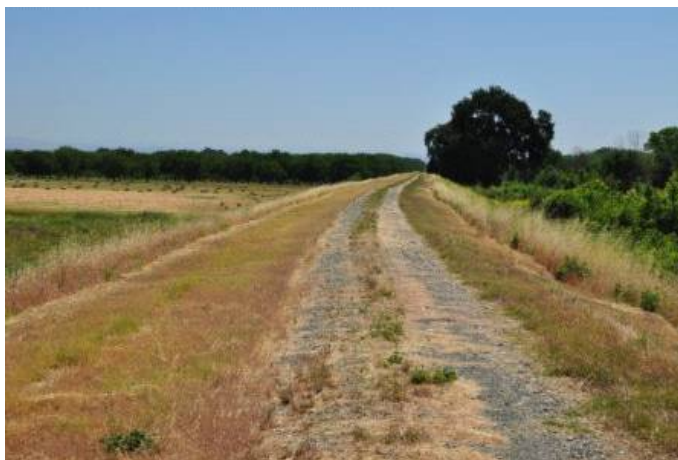
Levee Mile Report Line	1
Start Levee Mile	0.00
End Levee Mile	0.00
Location	Land Side
Category	Earthen Levee
Item	Vegetation

RD 817 Unit 2 - Vegetation

LMR No.	Levee Mile		Category	Item	* Location	Rating	Action/Comment	GPS Latitude/Longitude		Issue No.
	Start	End						Start	End	Photo
1	0.00	0.00	Earthen Levee	Vegetation	LS	A Ma	V1 : Control annual grass and weeds on the levee slopes and easements.	°	°	9
								°	°	Y
DWR ID: DWR_RD0817_02_s_2012_9										
2	0.27	0.27	Earthen Levee	Vegetation	LS	M Ma	V2 : Remove the wild growth other than native grasses from the levee slopes.	38.984377 °	38.984377 °	1
								-121.501553 °	-121.501553 °	Y
DWR ID: DWR_RD0817_02_s_2012_1										
3	0.32	0.32	Earthen Levee	Vegetation	LS	M Ma	V2 : Remove the wild growth other than native grasses from the levee slopes.	38.984467 °	38.984467 °	2
								-121.500488 °	-121.500488 °	Y
DWR ID: DWR_RD0817_02_s_2012_2										
4	0.39	0.39	Earthen Levee	Vegetation	LS	M Ma	V2 : Remove the wild growth other than native grasses from the levee slopes.	38.984542 °	38.984542 °	3
								-121.499283 °	-121.499283 °	Y

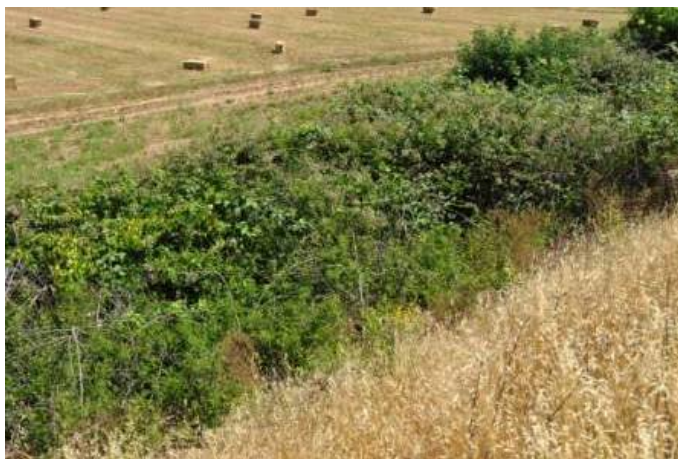
Levee Mile Report Line	2
Start Levee Mile	0.27
End Levee Mile	0.27
Location	Land Side
Category	Earthen Levee
Item	Vegetation

RD 817 Unit 2 - L/S Vegetation - Blackberries & Wild Rose

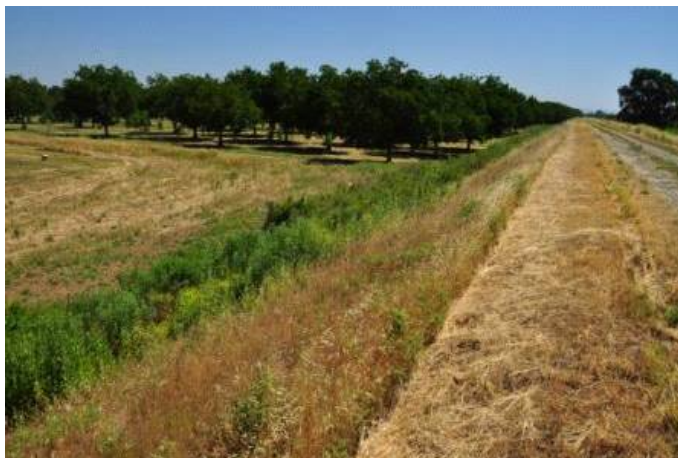
Levee Mile Report Line	3
Start Levee Mile	0.32
End Levee Mile	0.32
Location	Land Side
Category	Earthen Levee
Item	Vegetation

RD 817 Unit 2 - L/S Vegetation - Wild Rose

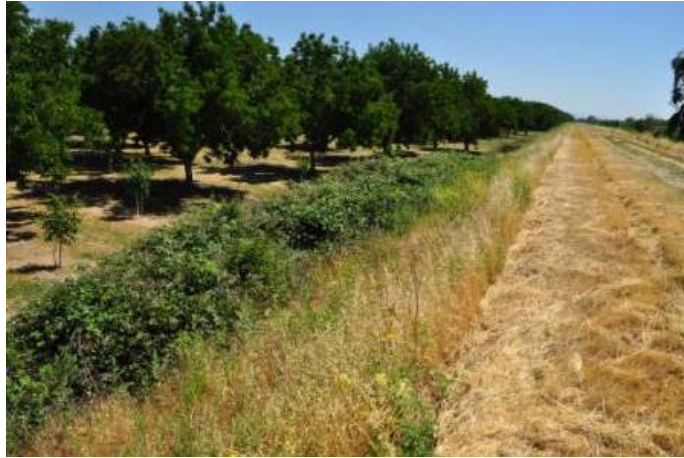
Levee Mile Report Line	4
Start Levee Mile	0.39
End Levee Mile	0.39
Location	Land Side
Category	Earthen Levee
Item	Vegetation
RD 817 Unit 2 - L/S Vegetation - Blackberries & Wild Rose	
rburnett_s_20120531_384.JPG

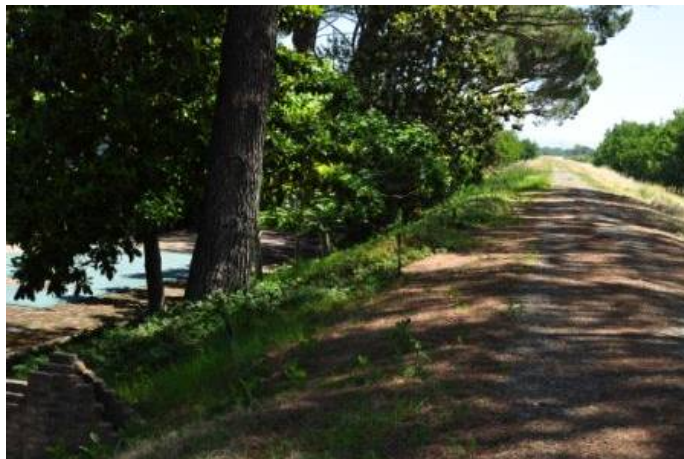
Levee Mile Report Line	5
Start Levee Mile	1.76
End Levee Mile	1.82
Location	Land Side
Category	Earthen Levee
Item	Vegetation
RD 817 Unit 2 - L/S Landscaping	
rburnett_s_20120531_385.JPG

DWR ID: DWR_RD0817_02_s_2012_3										
5	1.76	1.82	Earthen Levee	Vegetation	LS	M En	V6 : Landscaping	38.987792 °	38.988118 °	6
								-121.474295 °	-121.473372 °	Y
DWR ID: DWR_RD0817_02_s_2012_6										
6	2.08	3.19	Earthen Levee	Slope Stability	LS	M Ma	S1 : Repair slope instability.	38.989338 °	38.994124 °	10
								-121.468640 °	-121.449448 °	Y
DWR ID: DWR_RD0817_02_s_2012_10

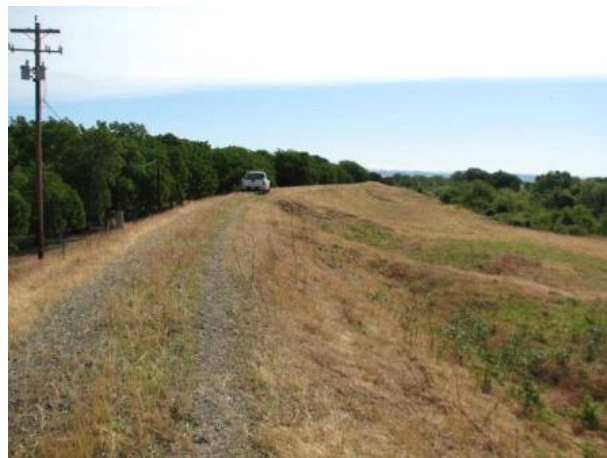
Levee Mile Report Line	6
Start Levee Mile	2.08
End Levee Mile	3.19
Location	Land Side
Category	Earthen Levee
Item	Slope Stability
Levee mile 2.08, this photo shows the slope is less than required, this is the downstream limit of the site, this is the waterside slope.	
rburnett_s_20120508_017.jpg

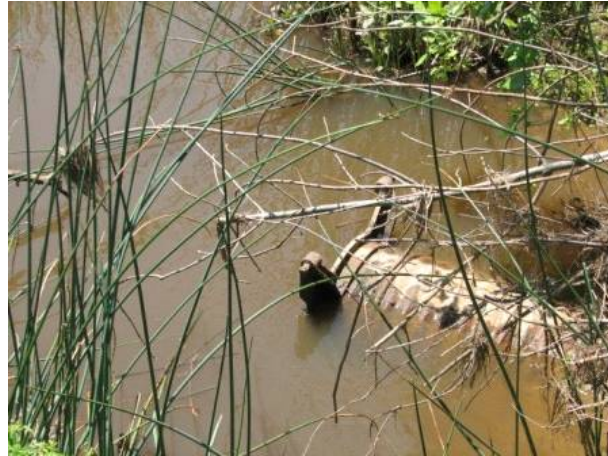
Levee Mile Report Line	3
Start Levee Mile	0.70
End Levee Mile	0.70
Location	Water Side
Category	Interior Drainage & Piping Systems
Item	Flap Gates

Levee mile 0.70, this is a photo of a missing flap gate at the waterside berm.

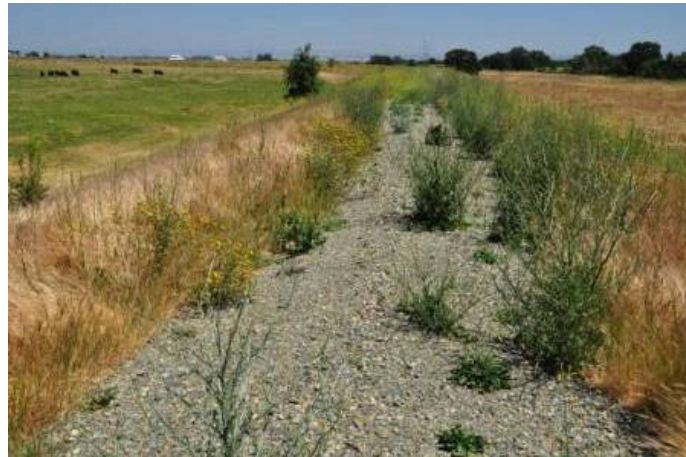
Levee Mile Report Line	4
Start Levee Mile	0.70
End Levee Mile	0.70
Location	Land Side
Category	Earthen Levee
Item	Vegetation

RD 817 Unit 3 - Vegetation (End of RD 784 Unit 6)

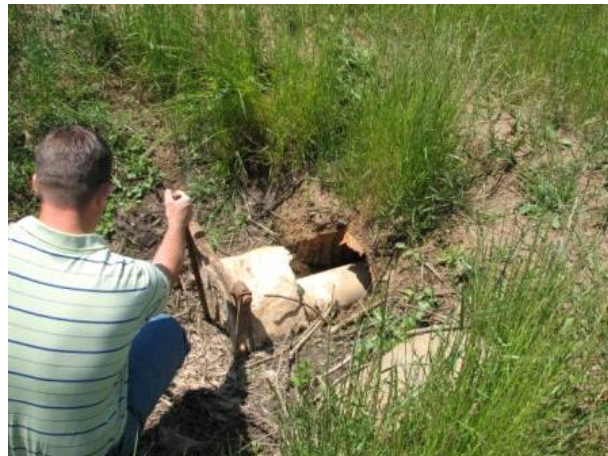
Levee Mile Report Line	6
Start Levee Mile	1.18
End Levee Mile	1.18
Location	Water Side
Category	Interior Drainage & Piping Systems
Item	Metal Pipes

5	0.75	0.75	Earthen Levee	Vegetation	LS	M Ma	V2 : Remove the wild growth other than native grasses from the levee slopes.	38.991758 ° -121.498702 °	38.991758 ° -121.498702 °	4
DWR ID: DWR_RD0817_03_s_2012_4										
6	1.18	1.18	Interior Drainage & Piping Systems	Metal Pipes	WS	U Ma		38.995873 ° -121.493130 °	38.995873 ° -121.493130 °	10 Y
DWR ID: DWR_RD0817_03_s_2012_10

Levee mile 1.18, this is a photo of a damaged pipe at the waterside berm.
